# THE GROWTH OF MULTI-SITE FATIGUE DAMAGE IN FUSELAGE LAP JOINTS

Robert S. Piascik  
NASA Langley Research Center  
Hampton, VA, 23681 USA.  
Tel: (757) 864-3483  
Fax: (757) 864-8911  
E-Mail: r.s.piascik@larc.nasa.gov

Scott. A. Willard  
Lockheed Engineering and Sciences Co.  
Hampton, VA, 23681 USA.

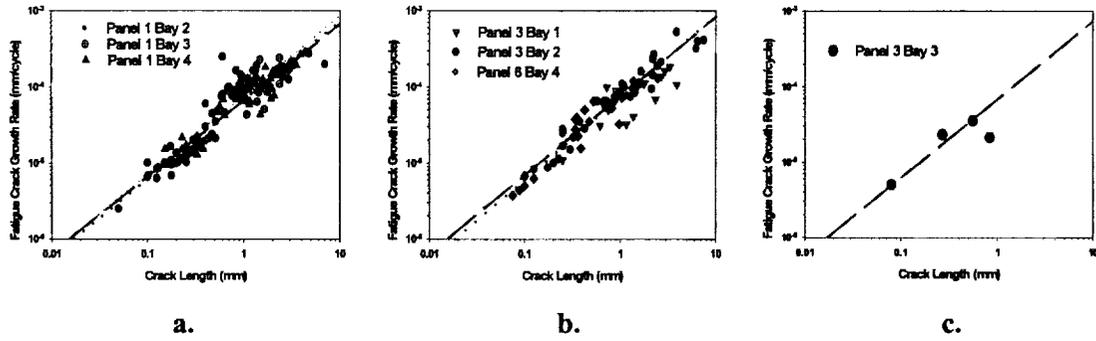
The data shown in Figures 6 and 7 show that upper rivet row fatigue cracks contained in panels 1, 3, and 6 exhibit identical crack growth characteristics. Figures 6a, 6b, and 6c are plots showing marker band based fatigue crack growth rate ( $da/dN$ ) data for cracks propagating from counter bore rivet holes, straight shank rivet holes, and 100° counter sink rivet holes, respectively. A comparison of the linear regression analysis (dashed and dotted lines) in Figures 6a and 6b reveal that:

A minimal amount of data from 100° counter sink rivet holes is shown in Figure 6c for panel 3 (bay 3). The excellent agreement of 100° counter sink crack growth rate data with the linear regression

analysis from Figures 6a and 6b (dashed line in Figure 6c) suggests that all fatigue cracks contained in the three different rivet configurations exhibit similar crack growth rate characteristics. A summary of all marker band based  $da/dN$  data is presented in Figure 7. This plot reveals that fatigue crack growth in riveted lap joint fuselage structure is well behaved; here, no appreciable difference is observed for data obtained from three rivet configurations, seven lap joint bays, and three different fuselage locations. The quantitative data in Figure 7 strongly suggest that the fatigue crack growth behavior of lap joint cracks ranging in size from 50  $\mu\text{m}$  to 10 mm is deterministic and predictable.

Figure 6. Plots of fatigue crack growth rate versus crack length for the a) counter bore rivet, b) straight shank rivet, and c) 100° counter sink rivet.

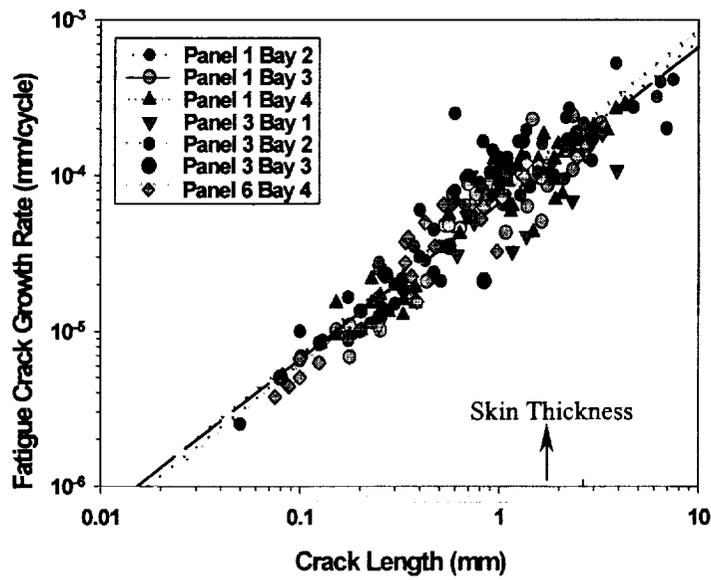
Figure 7. Summary of marker band based fatigue crack growth data from panels 1, 3, and 6.

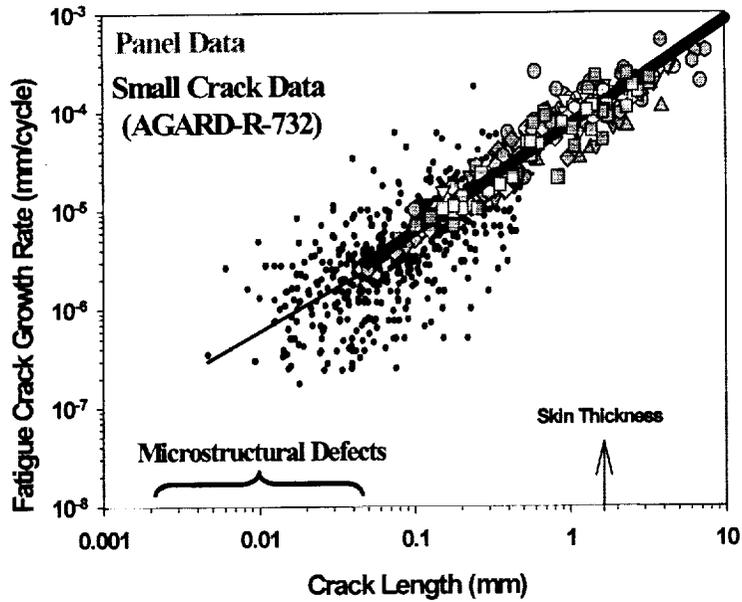
Figure 8. Comparison of small crack growth laboratory data and lap joint marker band based crack growth data from panels 1, 3, and 6.

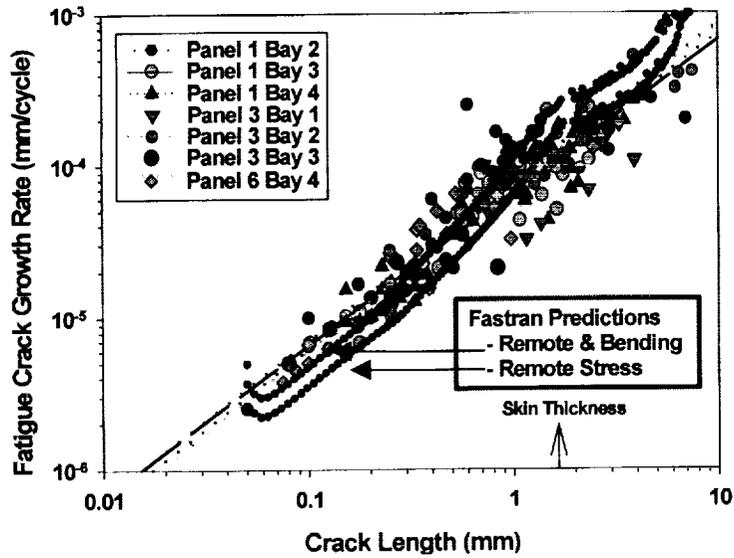
Fatigue crack growth predictions made by FASTRAN, a plasticity-induced crack closure based code, are in excellent agreement with lap joint marker band derived crack growth data. Compared in Figure 9 are the fatigue crack growth data and linear regression analysis results (dashed and dotted lines) from the destructive examinations conducted on panels 1, 3, and 6 and the results of two FASTRAN predictions (5). The combined remote and bending load prediction is in good agreement with the panel data for crack lengths of less than one skin thickness and nearly duplicate the linear regression results. The prediction, using only remote stress, under predicts crack growth rates in the short crack regime (<1 mm). The abrupt transition in the predicted results at crack lengths equal to the skin thickness is due to the change in the crack-tip stress intensity factor expression as the subsurface crack emerges through the outer skin thickness. The results shown in Figure 9 demonstrate that fracture mechanics based analytical methods accurately predict the fatigue crack growth rate behavior in lap joints from distinctly different fuselage locations and containing different rivet configurations (counter bore, straight shank, and 100° counter sink rivets).

Figure 9. Comparison of two FASTRAN Code predictions (remote plus bending stress and bending stress) and crack growth rate data obtained from real aircraft lap joint structure.
